Saw Mill Dam

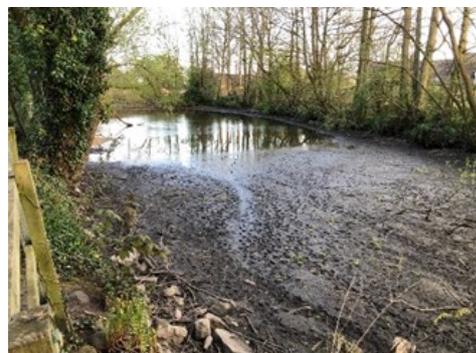
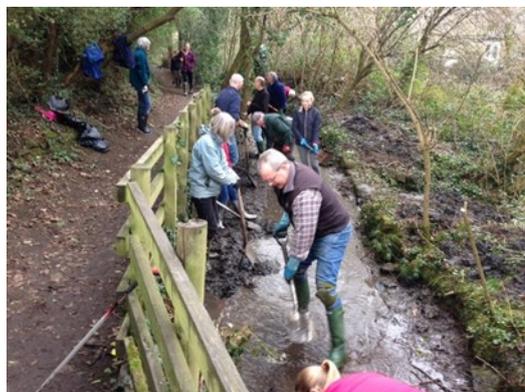
Whilst it is a popular place in the village and the surrounding trees provide a good wildlife habitat, the pond itself is in poor ecological condition. Water flow into the pond is unreliable as the culvert under the road becomes frequently blocked by shingle after high flow events in Town Beck. The trees around the pond are now too tall and prevent light reaching the pond surface and leaves from the trees are slow to decay causing poor oxygen conditions and the development of shoreline habitats. Most problematically the large number of ducks on the pond keep the water turbid disturbing the sediment as they feed further restricting light penetration into the water column and preventing the growth of submerged aquatic plants.

As it is likely that any attempt to control the duck population would be met by stiff opposition within the village there is little prospect of restoring the pond to good ecological status. However, it should be possible to improve water flow into and through the pond both to keep it well oxygenated and to stop it drying out. Without water inflow the pond will lose water quite rapidly, partly through evaporation but mainly by seepage through its bed.

The footpath follows the edge of the pond and along the goit towards Bolton Road. The goit is partly filled with silt brought down by water from Town Beck. Removing the silt from time to time is important to maintain water flow but the shingle in the culvert under Bolton Road causes the main blockage and is not easy for volunteers to remove. We are hoping Bradford Council will come to the rescue.
