## Pumping Station Storm Overflow

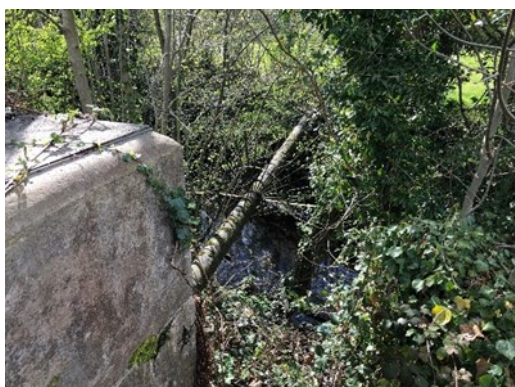
The iron gates leading into a field mark the point where a bridge crosses the channel of the mill race from the former mill. It's now called Mill Stream. A steel pipe crosses the channel alongside the bridge, constructed in the 1970s to take sewage from the Addingham Pumping Station to be treated at the Ashlands Sewage Treatment Works in Ilkley (see SW 13).

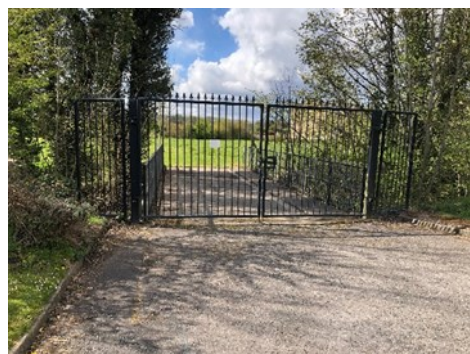
The Mill Stream now carries very little water as it is no longer connected to the Wharfe at its upper end. However, this is the channel that receives very large volumes of untreated sewage after very heavy rainfall when the capacity of the storm overflow tanks at the nearby Pumping Station (POI 13) is exceeded. Unfortunately, without going down the lane a little way, turning into the small woodland and pushing through the thorny undergrowth you are unable to see the point of discharge.

Discharges only occur on a few occasions each year but on those occasions the whole channel rapidly fills with dilute untreated sewage. It escapes slowly into the Wharfe after passing through the culvert under the road at the junction with the Old Ilkley Road. During these "spills" concentrations of pathogenic bacteria reach very high values in the Mill Stream.

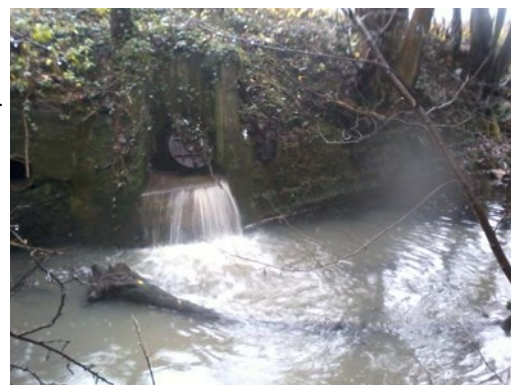
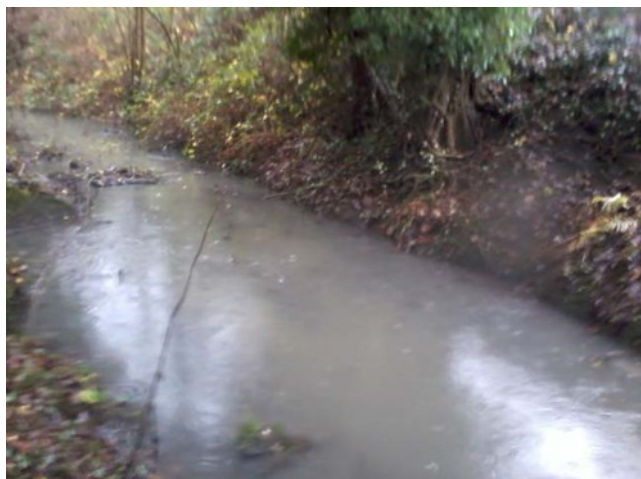
The high volume of relatively clean water in the Wharfe dilutes the effluent to a significant extent but nevertheless high concentrations of faecal bacteria such as E. coli remain in the river and are carried down to the recreational beaches in Ilkley. This upstream pollution source will need to be controlled if the newly designated bathing beach in Ilkley is to achieve a satisfactory rating.
